Manhole Inspection Summary

Manhole # S05CC1002MH

Insp Date: **6/27/07 4:18 PM**

Location Address: **4010 BELLE AVE** Cross Street: **GARRISON BLVD**

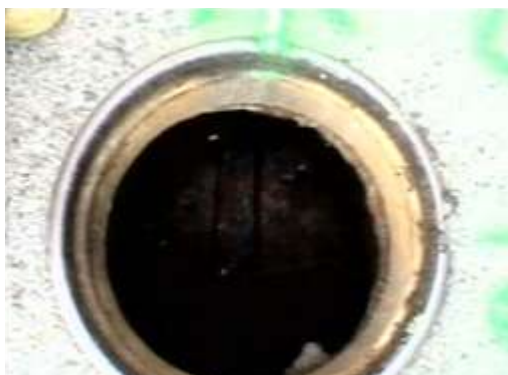
Top View

DEBRIS ON BENCH AND CHANNEL

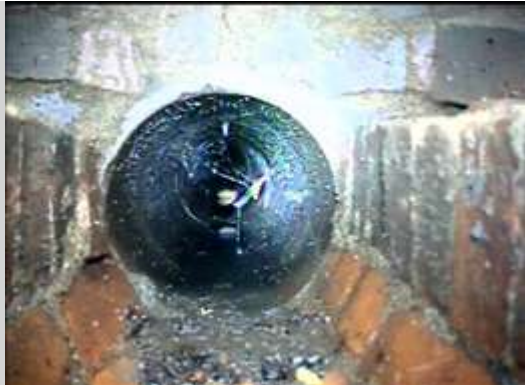
12 O'Clock Outflow

8 in. Circular Gravity Sewer
Pipe Out @ 12 O'Clock

Pipe Material: **Clay** ☐ Pipe Lined

Invert Depth: **5.70** (ft.) Flow Characteristics: **None**

Deposits: ☒ None ☐ Mud ☐ Sludge ☐ Debris ☐ Grease

Infiltration: **None** Pipe Seal Cond: **Sound**

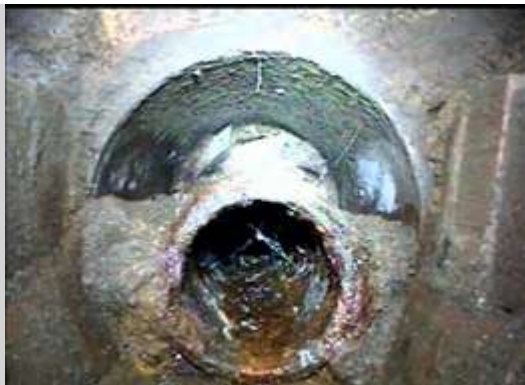
6 O'Clock Inflow

4 in. Circular Gravity Sewer
Pipe In @ 6 O'Clock

Pipe Material: **Unknown** ☐ Pipe Lined

Invert Depth: **5.67** (ft.) Flow Characteristics: **None**

Deposits: ☒ None ☐ Mud ☐ Sludge ☐ Debris ☐ Grease

Infiltration: **None** Pipe Seal Cond: **Sound**

Connects To: **House connection / Service line**
